Wind River HOA
Tulsa, OK

Report #: 47181-0
Beginning: January 1, 2024
Expires: December 31, 2024

RESERVE STUDY
"Full"

October 11, 2023

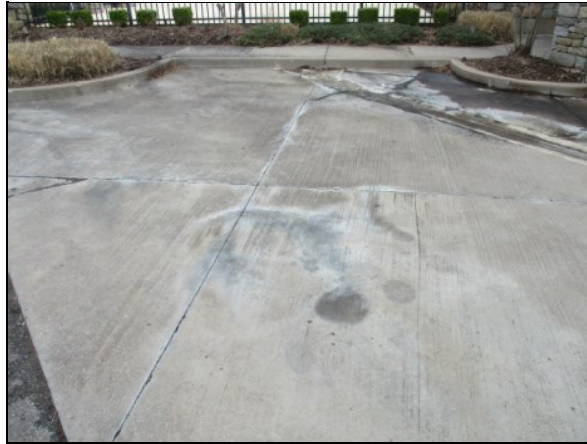
Comp #: 206 Concrete: Parking Lot - Repair

Useful Life:
20 years

Remaining Life:
10 years

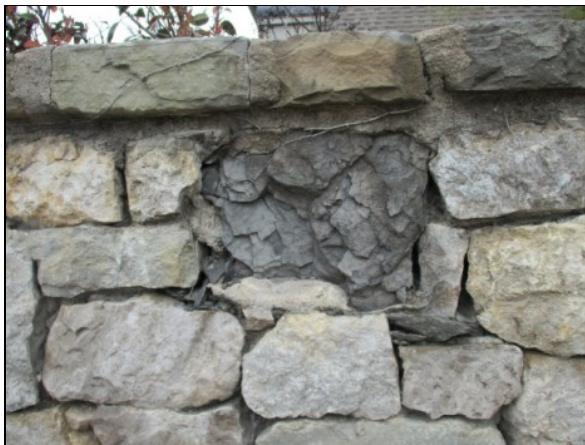
The walls are intact and in good condition. Local areas of missing stone observed. There's no expectation for a complete replacement of the walls within the 30-year scope of this study. Best to inspect on a regular basis for damage and deterioration. This component should be re-evaluated during future reserve study updates. Funding should be evaluated with information available at that time.

Useful Life:
10 yearsRemaining Life:
5 years

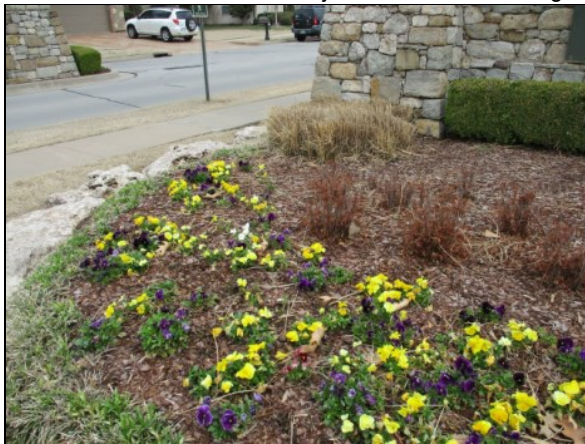
Comments: Routine daily/weekly/monthly maintenance is expected to be funded through the Operating budget. However, this component represents a supplemental "allowance" for larger projects which may occur periodically, such as renovation/restoration of landscaped areas, new trees, hedges, flower beds, etc. Timing and costs of such projects are very subjective. Estimates shown here should be re-evaluated by the Association over time and adjusted as needed during future Reserve Study updates.

Useful Life:
20 yearsRemaining Life:
19 years

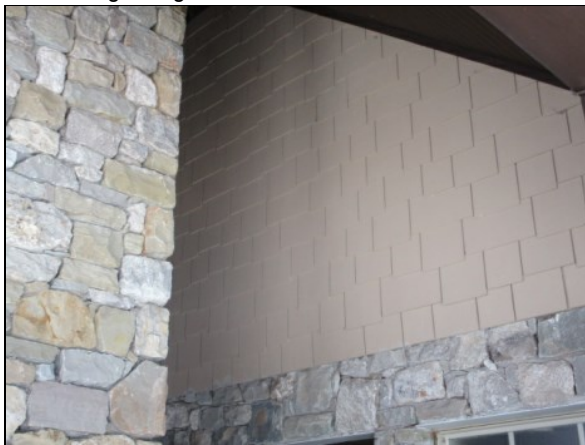
Association Reserves does not specifically endorse any products, manufacturers or vendors, but James Hardie Building Products, Inc. is the leading manufacturer of fiber cement siding, and their website (www.jameshardie.com) is an informative resource for proper care and maintenance of fiber cement siding. Their "Best Practices" guidelines offer specific guidelines for materials to be used; we strongly recommend complying with recommendations specific to your geographical area. We recommend that the Association consult with qualified exterior painting/waterproofing consultants and/or contractors to ensure that proper materials are used in painting and sealing the building siding.

Useful Life:
50 yearsRemaining Life:
33 years

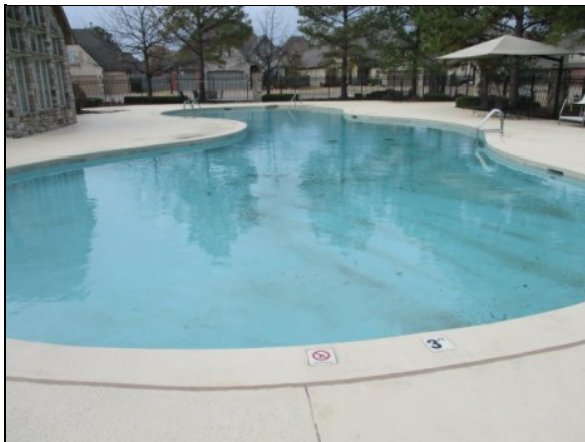
Please refer to the prior component in this series for more general information. Useful life, remaining useful life and cost ranges for this specific component are provided below.

Useful Life:
10 yearsRemaining Life:
9 years
