Wind River HOA
Tulsa, OK

Report #: 47181-0
Beginning: January 1, 2024
Expires: December 31, 2024

RESERVE STUDY
"Full"

October 11, 2023

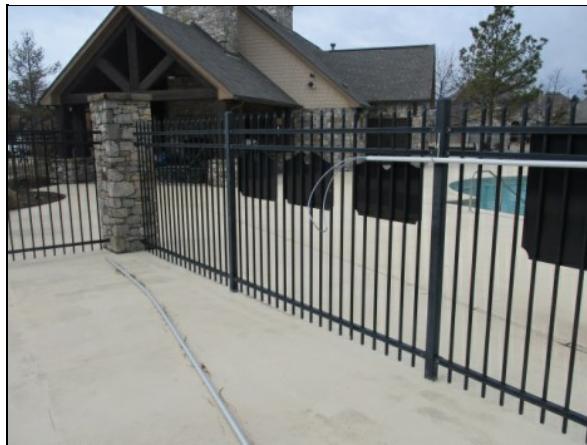
Comp #: 503 Fencing: Metal - Replace**Quantity: ~ 352 LF**

Comments: Metal fencing determined to be in fair condition typically exhibits some minor to moderate amounts of surface wear and other signs of age, which may include corrosion, loose or unstable pieces/sections or hardware, and/or overgrowth by surrounding vegetation. Overall, appears to be in serviceable but declining condition.

In our experience, metal fencing will typically eventually break down due to a combination of sun and weather exposure, which is sometimes exacerbated by other factors such as irrigation overspray, abuse and lack of preventive maintenance. For some types of fencing, complete replacement is advisable over recoating or refinishing due to relatively short lifespan of coatings and consideration of total life-cycle cost.

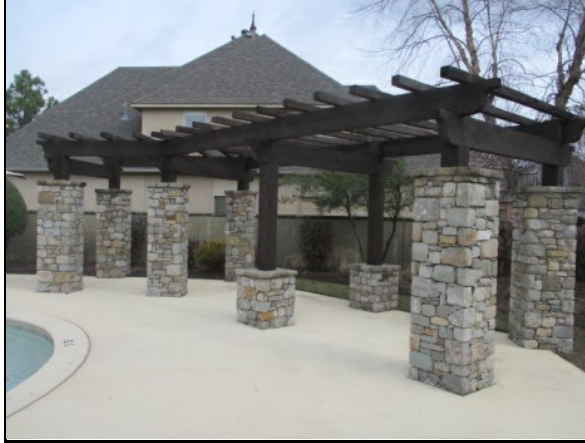
Comp #: 509 Pergolas - Replace

Comments: Pergola structures determined to be in good-fair condition typically exhibit good, consistent finishes or coatings and all frame members and hardware appear to be strong and sturdy. Best to repaint as a general operating expense.

As routine maintenance, inspect regularly and repair individual pieces or sections as needed from general Operating funds. Clean and paint/stain along with other larger projects or as general maintenance to preserve the appearance of the trellis and extend its useful life. If present, vegetation should be well-maintained and not allowed to become overgrown, which can eventually compromise the structure. Assuming ordinary care and maintenance, plan for major repairs or possibly complete replacement (if warranted) at roughly the interval indicated below.

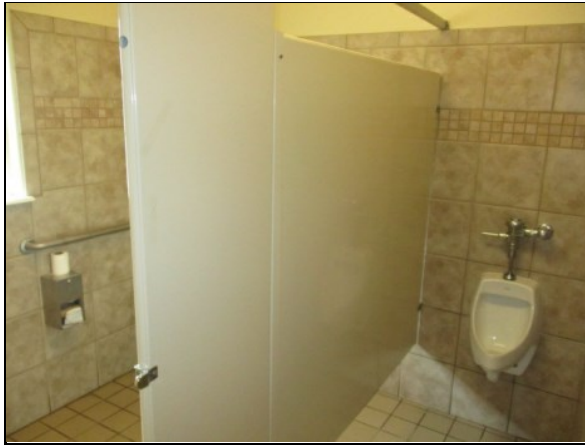
Restrooms determined to be in fair condition typically exhibit some light to moderate signs of use and age. Finishes are clean but showing some wear. All fixtures are assumed to be functional, but may be becoming outdated at this stage. Generally in serviceable condition.

As routine maintenance, inspect regularly and perform any needed repairs promptly utilizing general Operating funds. Typical remodeling project can include some or all of the following: replacement of plumbing fixtures, partitions, countertops, lighting, flooring, ventilation fans, accessories, décor, etc. Best practice is to coordinate this project with other amenity areas, such as kitchens or other amenity rooms. Remaining useful life is based on consideration of materials, evident conditions, and/or remodeling/renovation history provided during the engagement. Costs can significantly vary based on an anticipated scope of work as well as materials chosen for remodeling/renovation. Unless otherwise noted, estimates shown are based primarily on light to moderate cosmetic remodeling, not complete "gut" remodel projects.

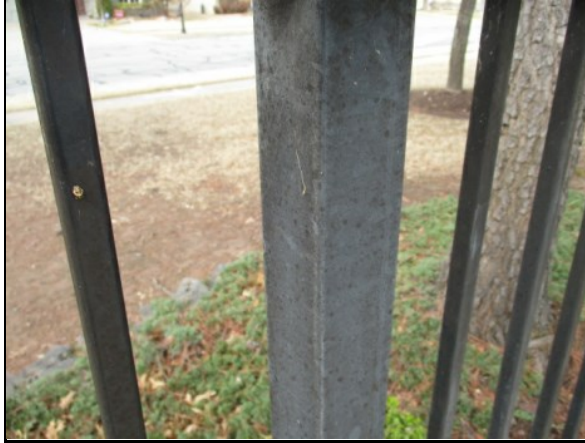
Comments: Metal fencing determined to be in fair condition typically exhibits a finish coat or surface which is mostly uniform but exhibits minor to moderate corrosion or rust. Coloring may be faded but is still mostly consistent. Fencing is powder coated but surfaces are beginning to fade.

Repairs and painting are expected to be included either in the Operating budget or through larger painting projects within the property/development at this time. However, any repair and maintenance or other related expenditures should be tracked, and this component should be re-evaluated during future Reserve Study updates based on most recent information and data available. If deemed appropriate for Reserve funding, component can be included in the funding plan at that time.

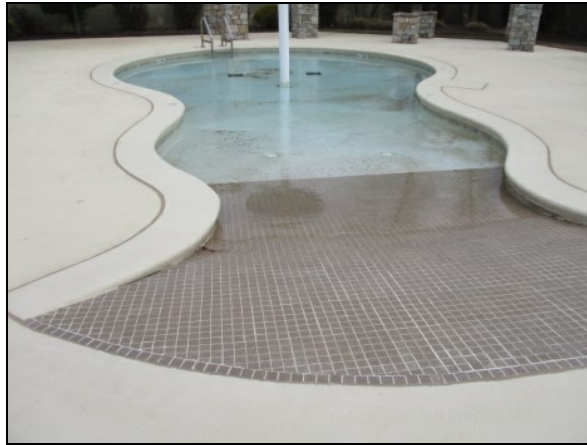
Comments: Feature pool is determined to be in good condition typically exhibit a generally smooth, consistent appearance with no noticeable chipping or cracking of the surface. Little or no staining or discoloration. Waterline tile/finish is clean and attractive with no cracked or missing tiles.

Minor repairs and routine cleaning/maintenance should be considered an Operating expense. Pool resurfacing will restore the aesthetic quality of the pool while protecting the actual concrete shell of the pool from deterioration. This type of project is best suited for slow/offseason to minimize downtime during periods when pool is used heavily. Should be expected at the approximate interval shown below; in some cases, schedule may need to be accelerated due to improper chemical balances or aesthetic preferences of the Client. While drained for resurfacing, any other repairs to lighting, handrails, stairs, ladders, etc. should be conducted as needed.

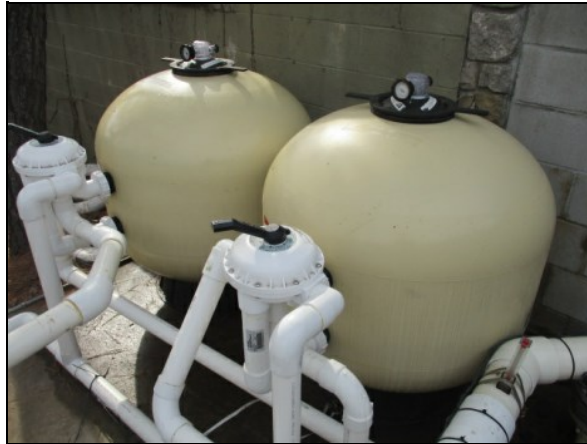
Comp #: 1219 Pool Equipment - Maintain/Replace

Comments: Includes: (2) main pool sand filters and (2) Jandy VFD pumps - recently replaced
(1) sand wader pool filter and (2) pumps - older.

Minimal or no subjective/aesthetic value for pool and spa equipment. Pool and spa pumps, filters, chemical feeders, and other miscellaneous equipment can be repaired or replaced for relatively low cost in most cases. Due to varying ages and/or information provided during this inspection, comprehensive replacement of all equipment at once is not anticipated. Thus, this component represents a "supplemental" allowance to repair, rebuild, and/or replace equipment as needed. Remaining useful life has been adjusted based on available visual condition, manufacture dates (if available), and/or Client cost history provided. The Client should continually track relevant repair/replacement expenses and report them during future Reserve Study updates. This component should then be re-evaluated based on the most current information available at that time.

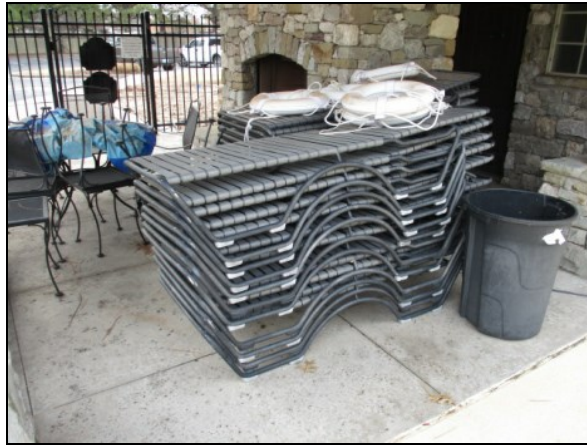
Comp #: 1230 Furniture: Pool - Replace

Pool furniture is determined to be in fair condition. Pieces show moderate usage and abrasions. At this stage rust may begin to develop and discoloration is present. Best to replace all of the pieces at the same time in order to maintain a uniform appearance.
